INSPECTION AND ANALYSIS
FOR THE
ROMAR TOWER
CONDOMINIUM

Orange Beach, Alabama

Prepared By:
Cornerstone Facilities Engineering, Inc.
January 2008

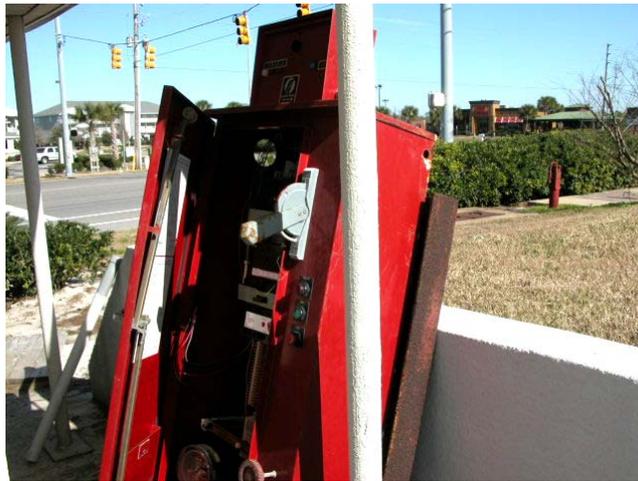
Old fire pump controller.

These items constitute a safety hazard especially for children who may get cut and/or crushed in attempting to play with these large metal objects. They should be removed as soon as possible.

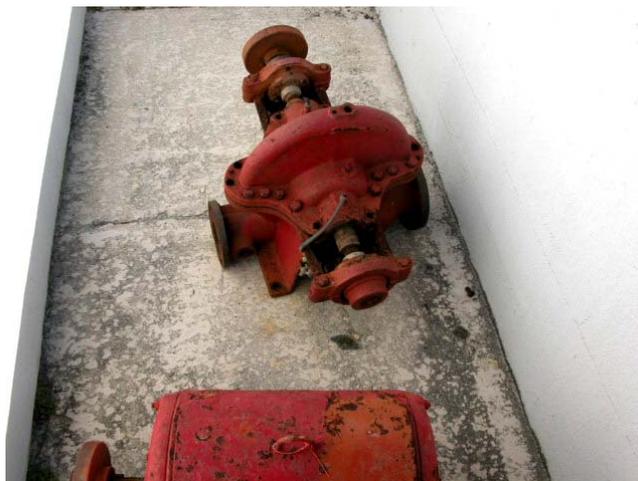
Old fire pump and motor.

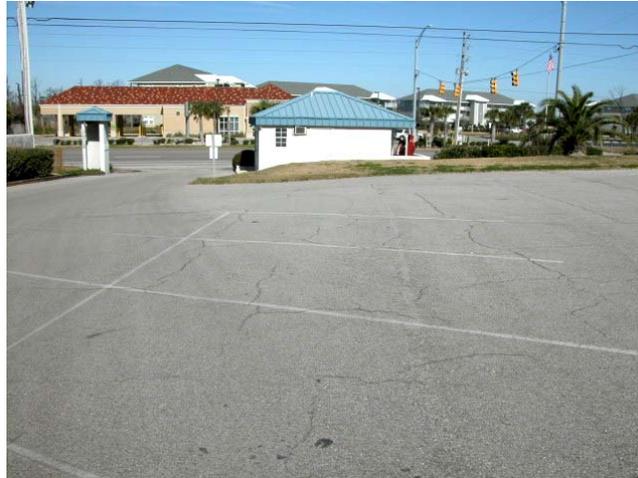
Asphalt paving in parking area.

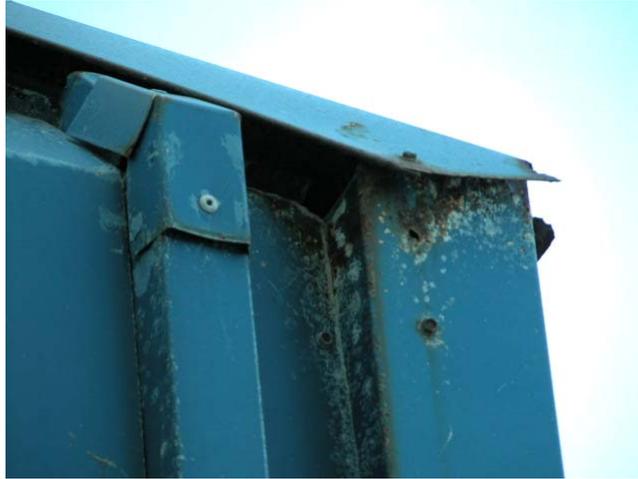
Metal Roofing at Entry: The metal roofing here is not in as good of a condition as the main roof. The photographs below show some of the distress.

Corrosion damage at roof corner.

It is suggested a fund be started to fund the replacement of the roofing. Based on the size of the roof this project will likely cost \$23,000. The current roof can be expected to last approximately another five years. The funding shown provides for the cost of this future project.

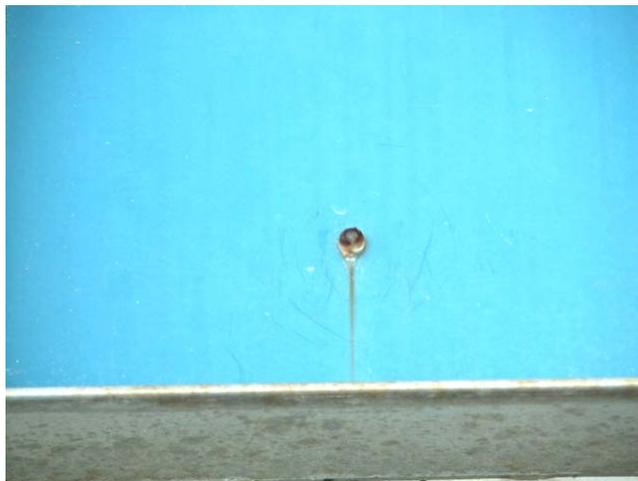
Corrosion of fastener that holds metal panel in-place.

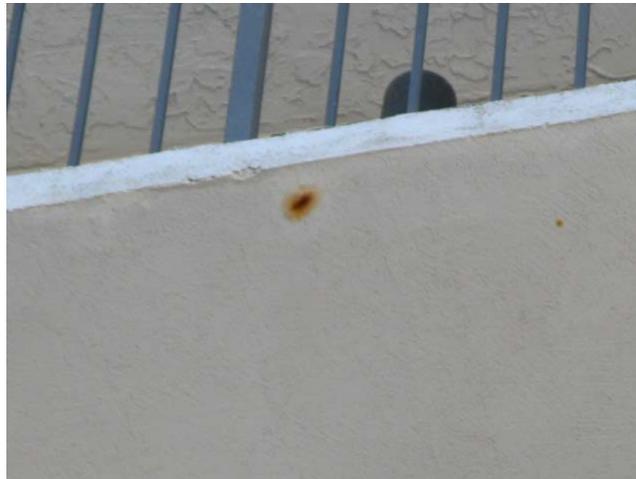
- 6. Walks, Balcony and Upper Walkway Concrete** – The concrete for the balconies and walkways are in good structural condition. There are signs that the reinforcement has been impacted by water intrusion over the years. Water

intrusion carries sodium chloride (salt) into the concrete and this in turn corrodes the reinforcing bars (rebar) that are in the concrete. The photograph below shows one area where this has occurred.

Rust spot forming on the concrete of a balcony.

The cost to correct those items has been estimated and shown on the spreadsheet. It is suggested the work be done in conjunction with the 2013 exterior coating and waterproofing project.

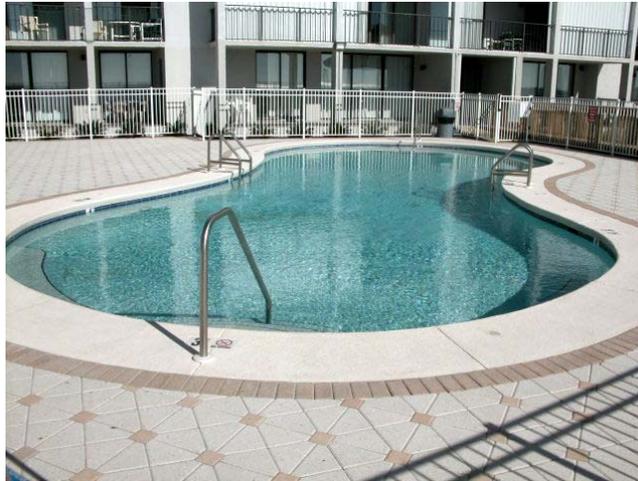
- 10. Pool and Spa Area and Equipment** - The pool was recently installed and is in very good condition. All mechanical systems are of first quality and should be capable of being maintained with normal maintenance. The budget shown should accumulate funds for upkeep of the pool and its related equipment. This fund will also be the source for refinishing the interior of the pool which will be required about every 10 years.

Pool and deck area.

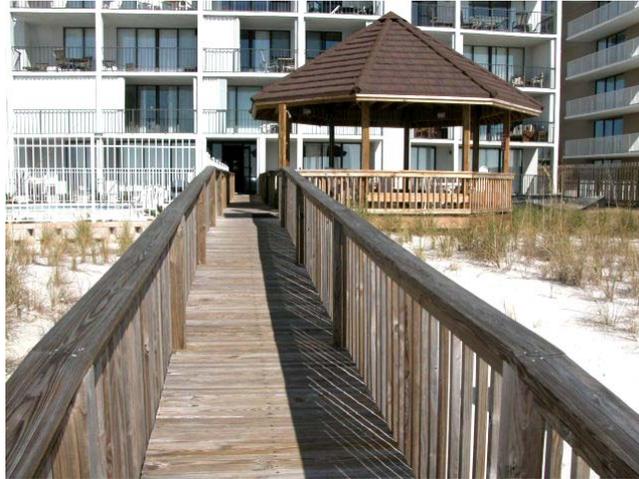
Beach Access & Gazebo

12. Beach Access Structure & Gazebo – The beach access structure is in good condition and has no current problems. A fund for regular repair of the structure should be considered to keep the walk in good repair and safe for use. Also this fund is to be used for maintenance of the gazebo.
